# Innovative Water System Battery Installation at Calipso Club

Report by Dr. Giovanni Barbieri, Director of Calypso Life Club Srl,  
Bibbiano (RE)

# The Installation of the IWS System

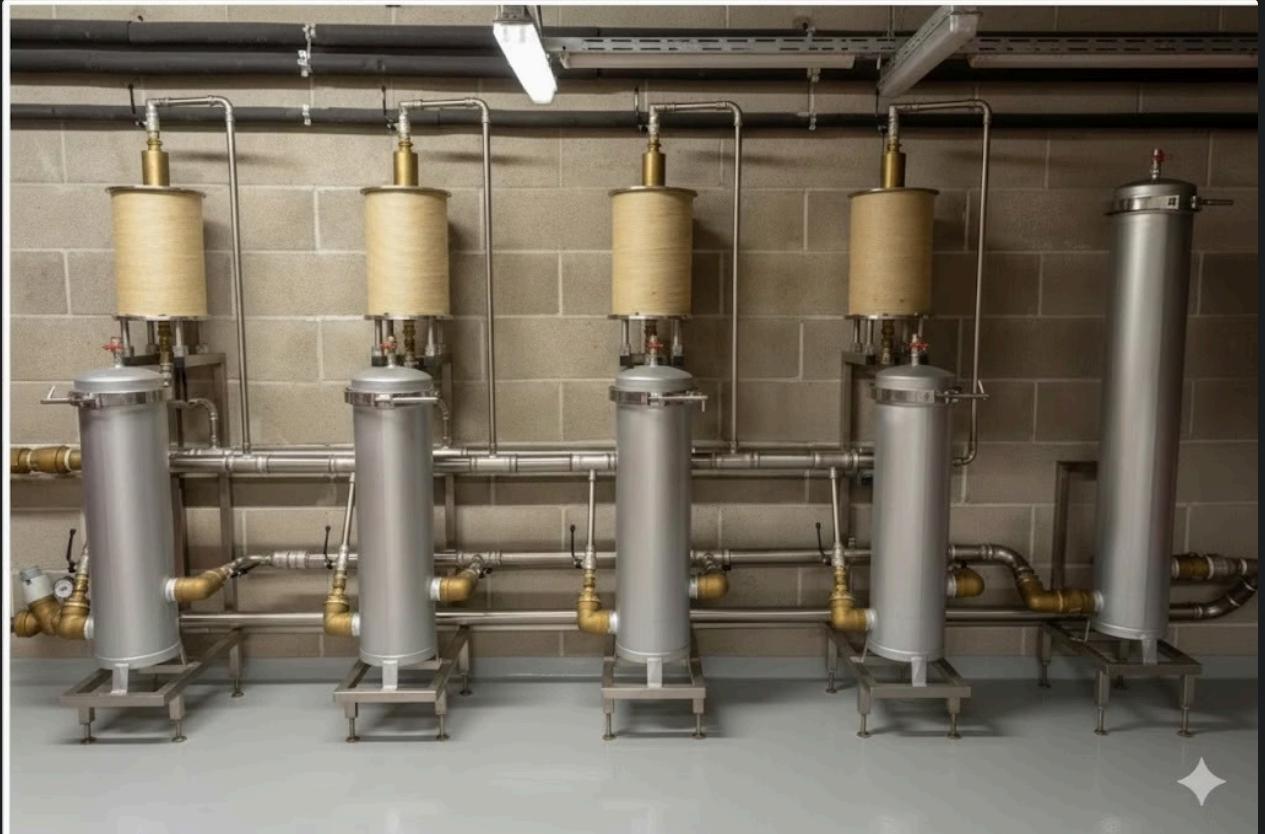
With the installation of the new battery regenerator system, the use of the water softener was excluded. The system immediately guaranteed correct pressure, and no anomalies occurred in the ordinary operation of the services.

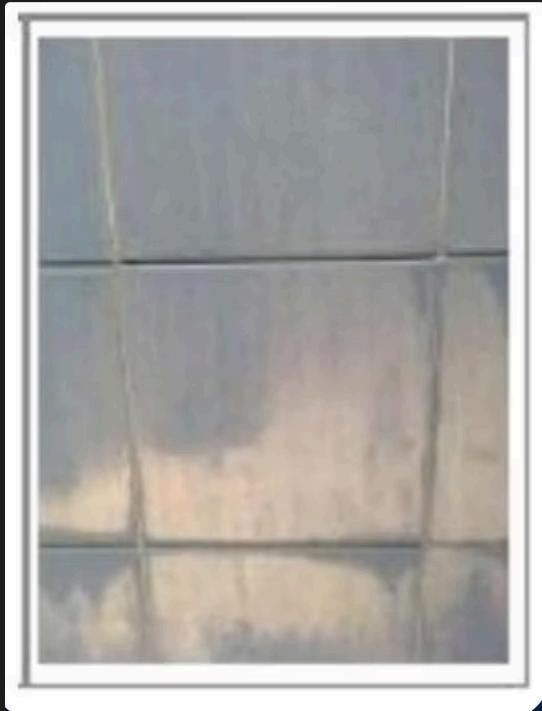
BEFORE

Unpleasant water taste (salty) and daily limescale deposits on shower tiles

Evident and daily deposits

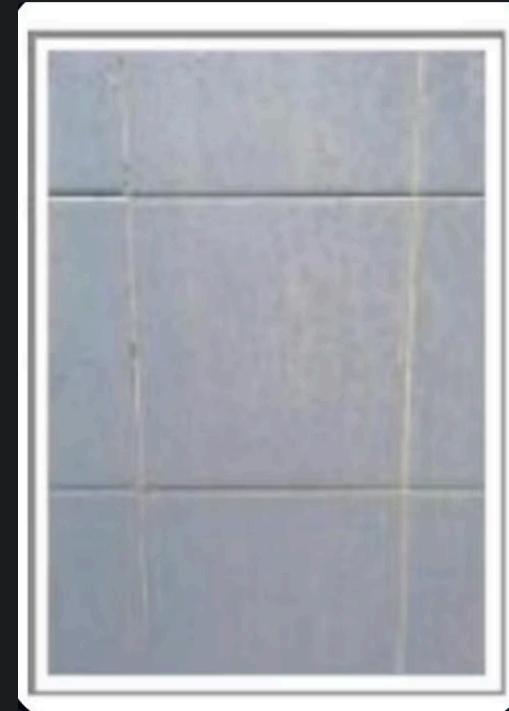
AFTER

Significant reduction in deposits

Limescale deposits on shower tiles have significantly reduced, lowering the routine cleaning effort. Since installation, maintenance of buttons and nozzles has been suspended without encountering any problems with shower functionality.

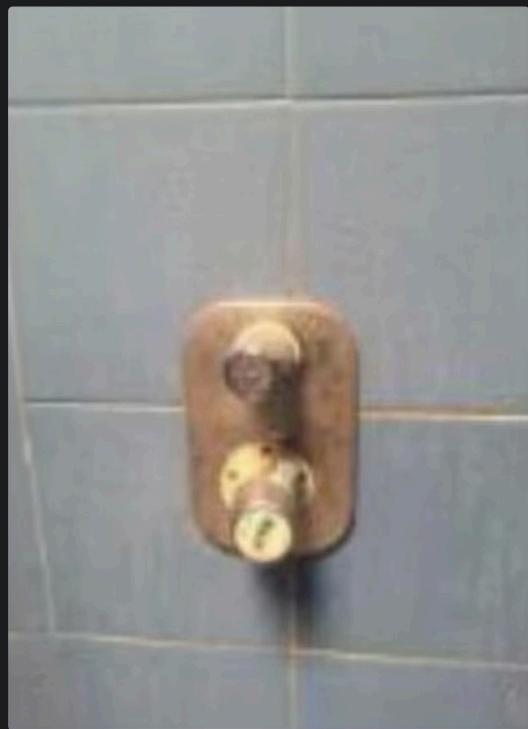
BEFORE

Mandatory maintenance every three months for cartridges, buttons, and nozzles to prevent blocks and clogs

Mandatory quarterly maintenance

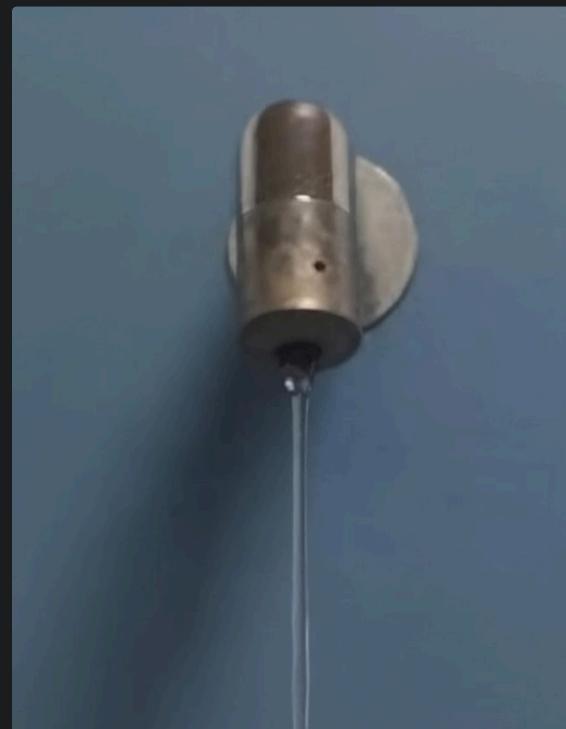
AFTER

Maintenance suspended without issues

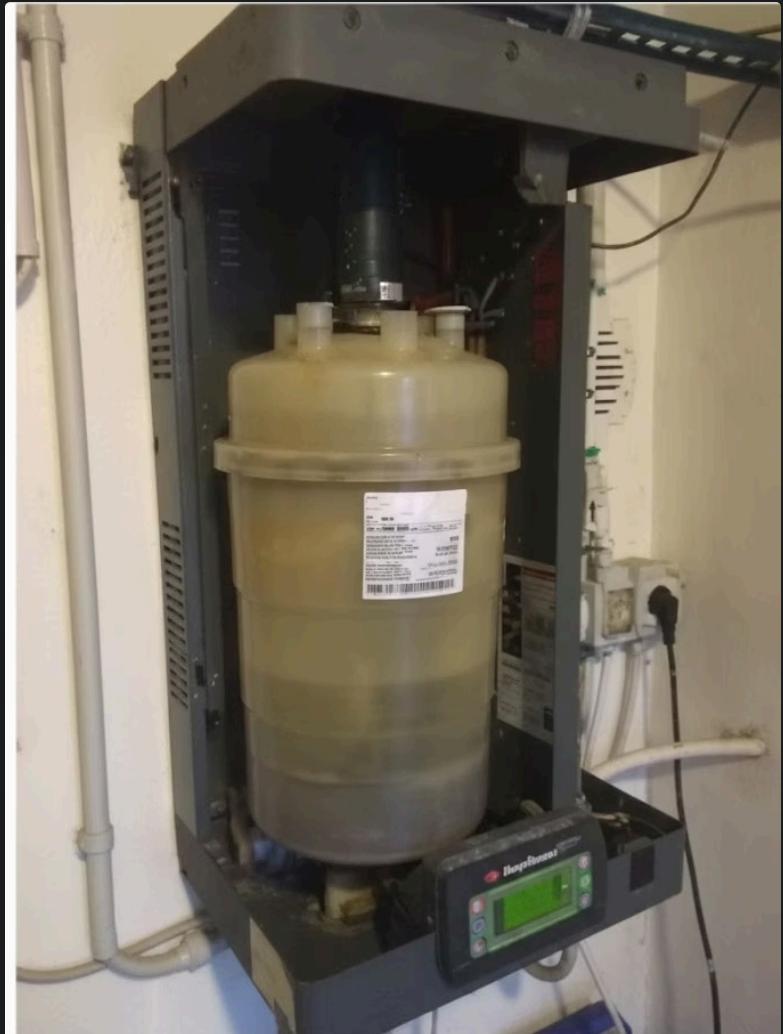
# Steam Boiler Turkish Bath: Zero Limescale

Since the last maintenance of the Turkish bath's steam boiler, after **10 months of use**, the boiler shows no signs of limescale.

Therefore, maintenance has been postponed, leading to significant savings in terms of time and costs.
